Repair and Rehabilitation Techniques Using in School of Engineering Building

Location of sight: - School of engineering building (R. K. University, Rajkot).

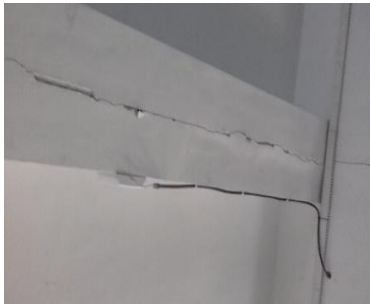
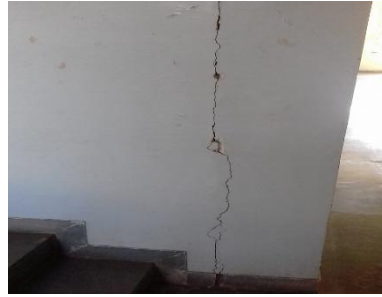
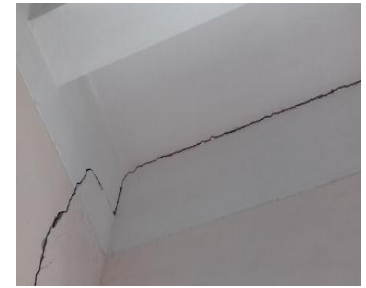
Layout of Cracks & Measurement

Damaged Expansion Joint

Vertical crack

Horizontal crack

Diagonal crack

W= 62mm
D = 1.4 cm, L = 11 m

W= 35mm, D = 60mm
L = 6m

W= 68mm, D = 64mm,
L = 1.5m

W= 4.10mm,
D = 4.9mm, L = 12m

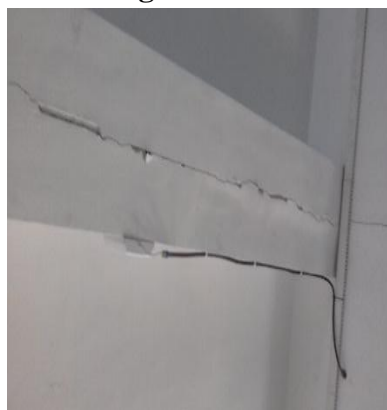
Damaged Expansion Joint

30.73
good layer

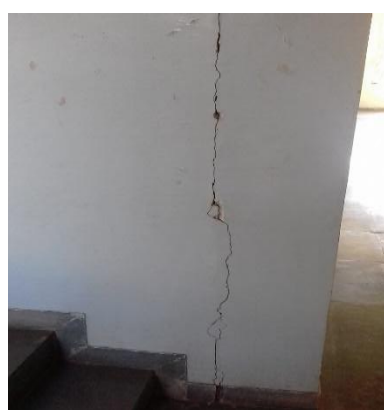
Vertical crack

35.05
good layer

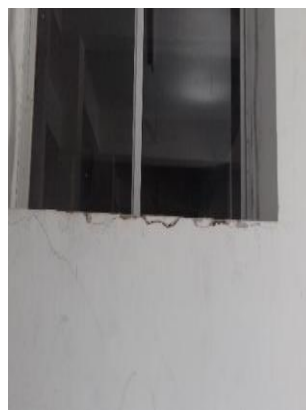
Horizontal crack

29.08
Fair

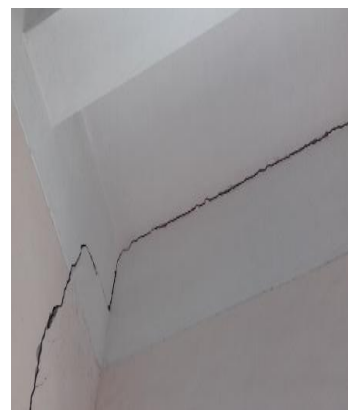
Diagonal crack

26.33
Fair

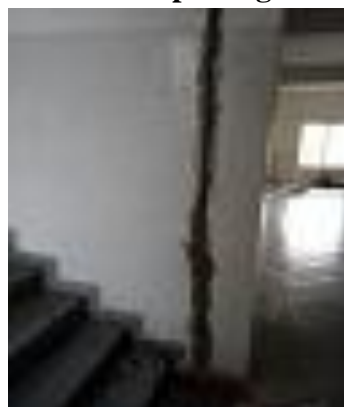
Vertical crack

46.08
Very good hard layer

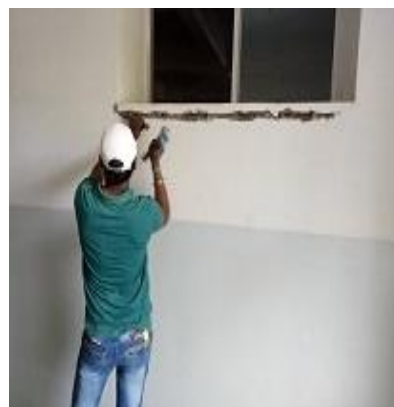
Horizontal crack

38.75
Good layer

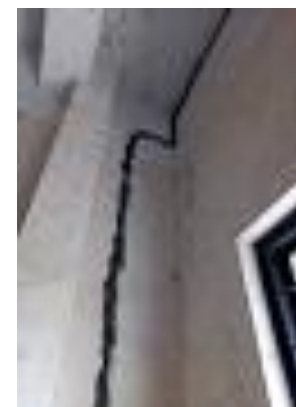
Diagonal crack

34.53
Good layer
