Direct Pulp Capping with Mineral Trioxide Aggregate and Reattachment of Fractured Fragment Using Ribbond Fibers - A Case Report

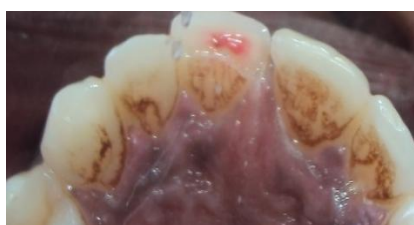
Intraoral examination revealed that the maxillary left central incisor was fractured in the oblique direction labially with the involvement of the pulp (crown fracture - Ellis Class II) [Figure 1a and b]. Upon examination of the fractured fragment, it was found that the fragment was in healthy condition and its approximation on the fractured tooth was good. The treatment options suggested to the patient were (1) pulp protection with direct composite resin restoration/or newer pulp protective materials (2) full coverage crown and (3) reattachment of the tooth fragment. After discussing about the advantages, disadvantages, prognosis and cost of every treatment option the patient opted to have the tooth fragment reattached.

Figure 1a and 1b Clinical pre-operative image with pulp exposure

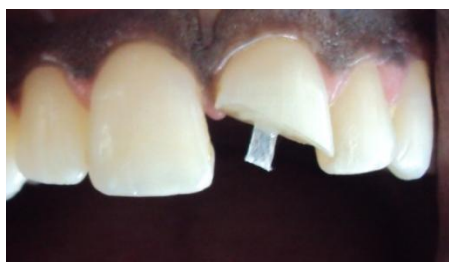
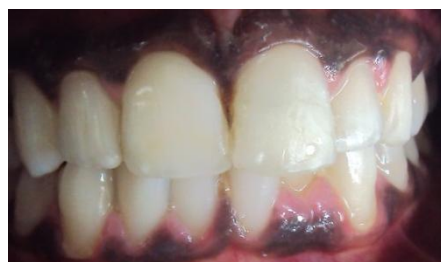
Figure 3a and 3b: Ribbon fiber placed in the coronal section of tooth for anchorage, final post operative clinical image

A small pre-measured piece (2 mm) of ribbon (Ribbon Inc., Seattle, WA, USA) was selected, bonding agent applied (Bond I, Pentron Technologies LLC) and cured for 20 s. The ribbon was placed vertically in the groove prepared in the fractured fragments along with panavia F dual cure cement (Kuraray, Osaka, Japan) [Figure 4a and 4b]. The fragment was then verified for a fit with the tooth surface to ensure proper adaptation. Excess cement was removed and light cured from both buccal and palatal side. The occlusion was carefully adjusted and the patient was instructed to avoid exerting heavy function on the reattached tooth. Patient was recalled after 6 months, vitality test was done with electric and cold test. The MLCI responded positively but MLCI showed no response.
