A Special Checklist in Obstetrics Patient during Central Venous Catheter Insertion: Is it required?

Abstract

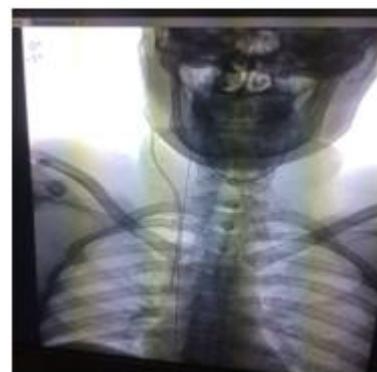
Figure I: Antero posterior view during fluoroscopy showing presence of guidewire in IJV.

A thirty-two-year-old female with period of gestation 25wks- G₂ P₁₀₀ admitted under obstetrics and gynecology department of our institution with diagnosis of intra uterine death (IUD) with type II placenta praevia. The patient delivered the fetus spontaneously followed by delivery of placenta. Two hours following delivery, patient started having torrential bleeding and immediate management was started on the lines of post partum hemorrhage. Despite transfusion of blood products patient was still hemodynamically unstable, the anesthesia team was called at 2:00 am to guide further resuscitation. Despite volume resuscitation patient had persistent hypotension and plan was formulated to shift patient to operating room (OR) for exploration/hysterectomy. Presenting vitals were: pulse rate-164/min, blood pressure: 104/68 mm of Hg, saturation of 98% on FiO₂-0.6. Patient was administered 50 mcg fentanyl and 50 mg ketamine intravenously for sedation. The gynecologist performed examination under anaesthesia (EUA) and uterine cavity was packed for tamponade effect. In view of volume status assessment and possible requirement of ionotropes ultrasound guided CVC insertion of right IJV was planned. After insertion of CVC line by a trainee anesthetist under supervision of senior resident, free flow was confirmed in all the three ports and CVC was fixed at 12 cm. The uterine artery embolisation was planned and patient was shifted to interventional radiology suite. At 5:30 am fluoroscopy done during embolization revealed retained guidewire extending from IJV to IVC (Figure I and II).

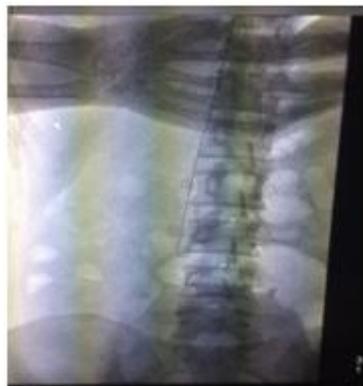
Figure II: Antero posterior view during fluoroscopy showing guidewire's abdomininal extension till L1 vertebral body.

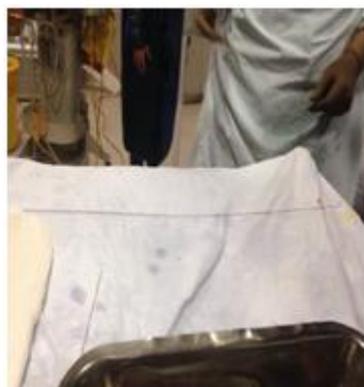
Figure III: Retrieved intact guidewire following the procedure. .

relatives of the patient were informed and consent was taken regarding the procedure. The guidewire was successfully removed through the femoral vein using gooseneck snare (Figure III). Approximately two to three minutes after retrieval of the guide wire the electrocardiogram of the patient showed ventricular premature complexes (VPC's). Patient remained conscious, oriented, asymptomatic and hemodynamically stable. Injection xylocard was given i/v 60 mg and repeated after few minutes leading to transient resolution of abnormal rhythm obtained. After five minutes interval patient again had ventricular tachycardia intermittently. Injection amiodarone 150 mg bolus given, cardiology call was sent, arterial blood gas analysis was sent and 12 lead ECG was done. Arterial blood gas analysis showed potassium level of 2.7 mEq and slow infusion of KCl 40 mEq was started. Intravenous amiodarone infusion was started at a dose of 1mg/min and ventricular tachycardia resolved within a span of 30 minutes. Patient was monitored in the radiology suite for 60 minutes and then shifted to cardiac care unit (CCU) in view of constant monitoring for arrhythmias. The patient was discharged on day sixth of hospital stay.
